Manhole Inspection Summary

Manhole # S25Q1_004MH

Insp Date: **3/4/08 9:33 AM**

Location Address: **3227 Lily Ave.**

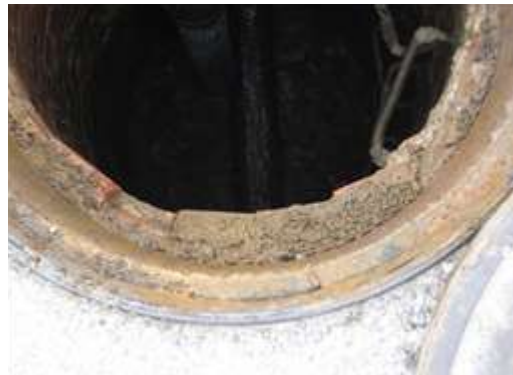
Defect 2

Frame Offset: **3** (in.) Condition: ☒ Sound ☐ Cracked ☐ Leaks

Frame offset

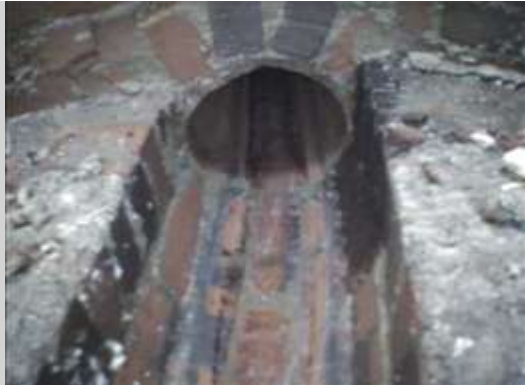
12 O'Clock Outflow

8 in. Circular Gravity Sewer
Pipe Out @ 12 O'Clock

Pipe Height: **9.6** (in.) Rod and Bar (Angled)
Pipe Material: **Clay** ☐ Pipe Lined
Invert Depth: **13.67** (ft.) Flow Characteristics: **Fast**
Deposits: ☒ None ☐ Mud ☐ Sludge ☐ Debris ☐ Grease
Silt Depth: (in.) Deposits Extent:
Infiltration: **None** Pipe Seal Cond: **Sound**

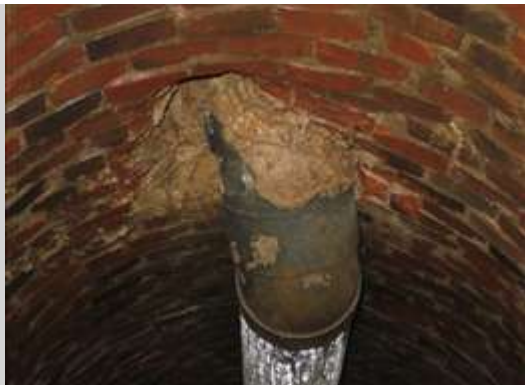
5 O'Clock Inflow

Comments **Could not measure influent pipe @ 5 O'clock due to inside drop.**

6 in. Circular Gravity Sewer
Pipe In @ 5 O'Clock

Pipe Height: **3.6** (in.) Rod and Bar (Angled)
Pipe Material: **PVC** ☐ Pipe Lined
Invert Depth: **3.00** (ft.) Flow Characteristics: **None**
Deposits: ☒ None ☐ Mud ☐ Sludge ☐ Debris ☐ Grease
Silt Depth: (in.) Deposits Extent:
Infiltration: **Evidence** Pipe Seal Cond: **Sound**

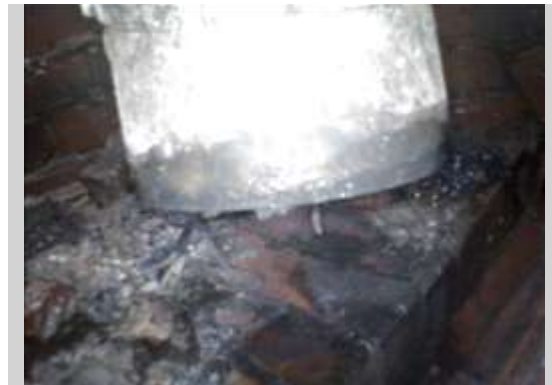
Drop In @ 5 O'Clock

Drop: **Inside** Rod and Bar
Angled: **Yes** Reading: **10.00** (ft.)
Inv Depth: **11.00** (ft.)
Drop Condition: **Open**

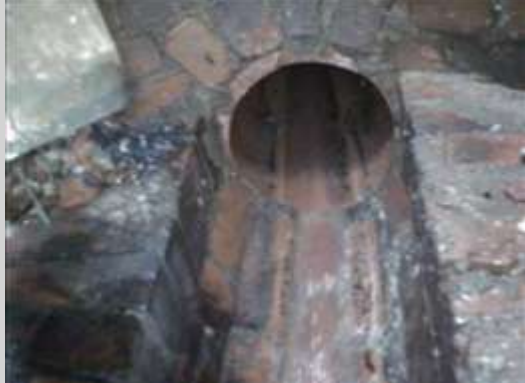
6 O'Clock Inflow

8 in. Circular Gravity Sewer
Pipe In @ 6 O'Clock

Infiltration: **None** Pipe Seal Cond: **Sound**
